Inspection Report Minerals Regulatory Program

Report Date: September 22, 2004

Mine Name: Little Cottonwood Granite Quarry

Permit number: S/035/017

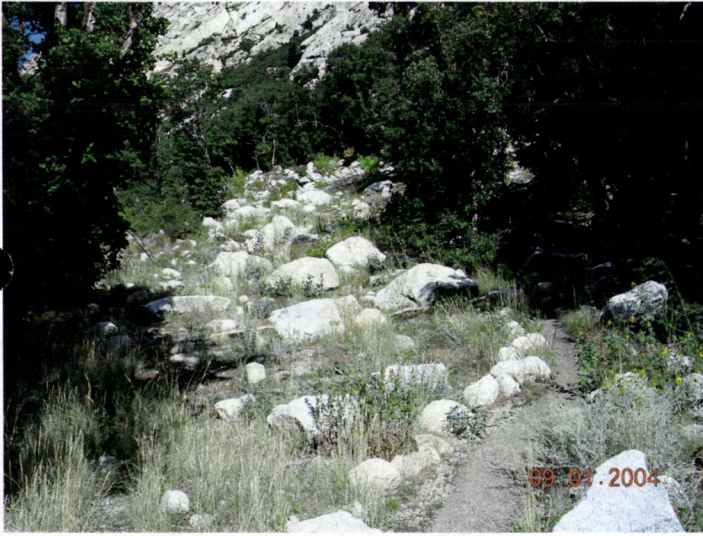
The site is just below a very popular climbing area, and there is a trail leading to this area through the disturbed area. It appears the climbers stay pretty well on the rock-lined trail without walking through the rest of the area (Photo 1).

Photo 1. Trail leading up through the disturbed area.

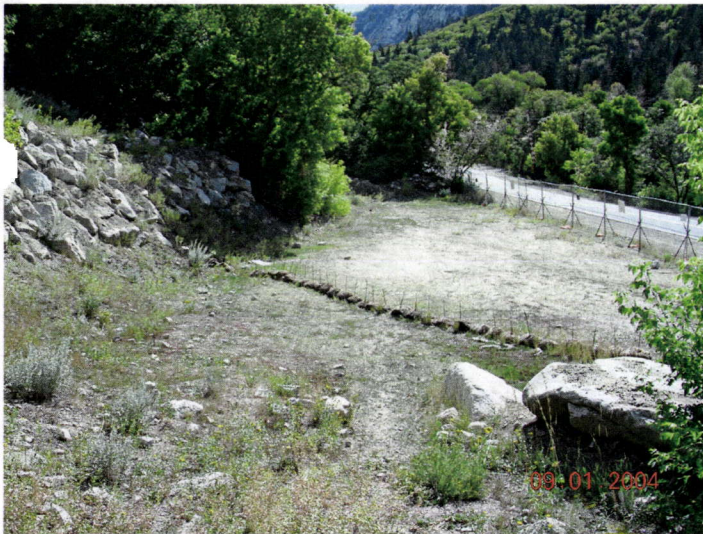
At the bottom of the disturbed area is an area to the side of the highway that climbers had been using for parking until the operator fenced it off (Photo 2). Although the fence installation is temporary, the operator does not want people parking there because of liability concerns. People now park on the other side of the highway and hike around the fence (Photo 3).

I understand from Greg Baptist (Salt Lake County Public Works) that the highway right-of-way extends 60 feet on either side of the highway center line and that the operator received permission to put the fence within the right of way. Much of the area shown in Photo 2 is in the right-of-way, but I did not measure to see exactly how much.

The only area where I have some reservation whether there is adequate vegetation is the area next to the road that was previously used for parking (Photo 2). The soil in this area was compacted to the extent that it may take years for appreciable vegetation to become established, but the area that is most affected is within the highway right of way. If the temporary fence was removed, it is nearly certain people would once again park in this area. I consider this a land use issue that needs to be settled between the operator, the Department of Transportation, and Salt Lake County.

Photo 2. Area that had been used for parking until it was fenced.

Unless the operator has approval from UDOT to leave the fence in the right-of-way, it needs to be removed. Another fence could be built outside the right-of-way, but it would need to comply with county ordinances.

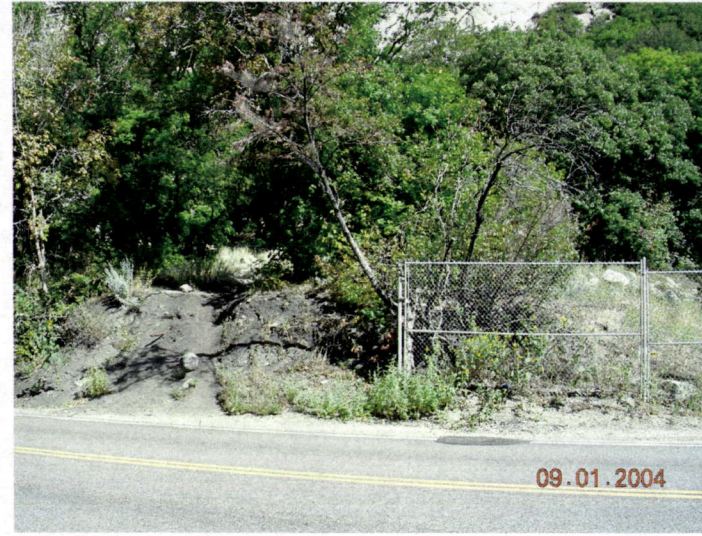
Photo 3. This is the place west of the fenced parking area where people go around the fence to get to rock climbing areas.

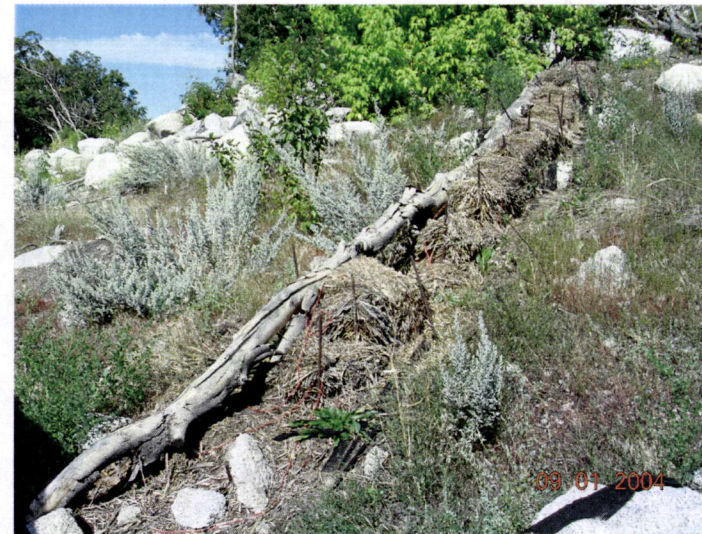
The operator had installed silt fences and straw bales (Photos 2 and 4), but most of these are no longer functional. These should be removed before the site is released. The straw could be spread around the site but should not be left in clumps. Baling twine needs to be removed.

Photo 4. Some of the sediment control structures that are no longer functional.

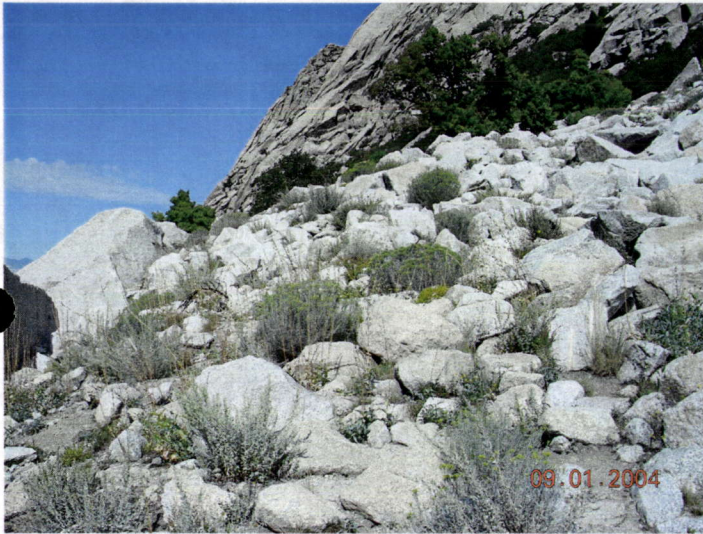
Vegetation on most of the site is very good (Photo 6), but there are some areas where weeds predominate (Photo 7). The cover does not approach 70 percent of the adjacent areas because adjacent areas have mature trees and much of the disturbed area is a talus slope (Photo 5). It is impractical to think the reclaimed area could have 50-60 percent cover in three years. Vegetation in most of the area has been established within practical limits (R647-3-109.13.12).

Photo 5. Part of the reclaimed area. Note the number of rocks and the amount of vegetation between the rocks.

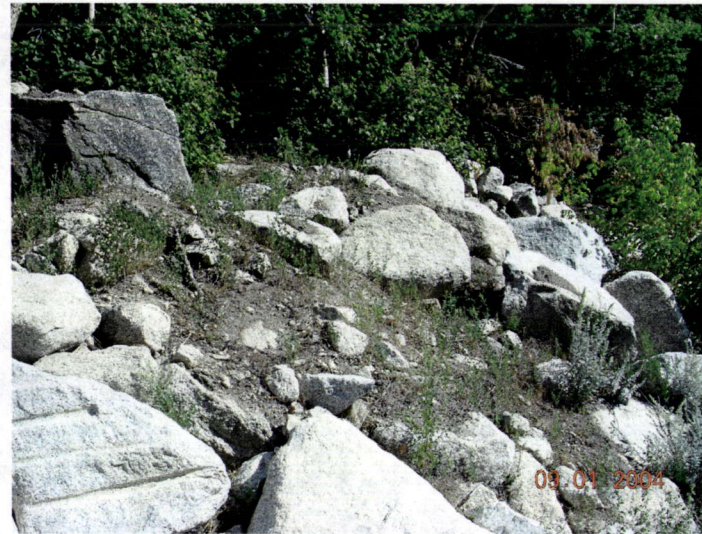
Photo 7. There are some areas where weeds predominate.

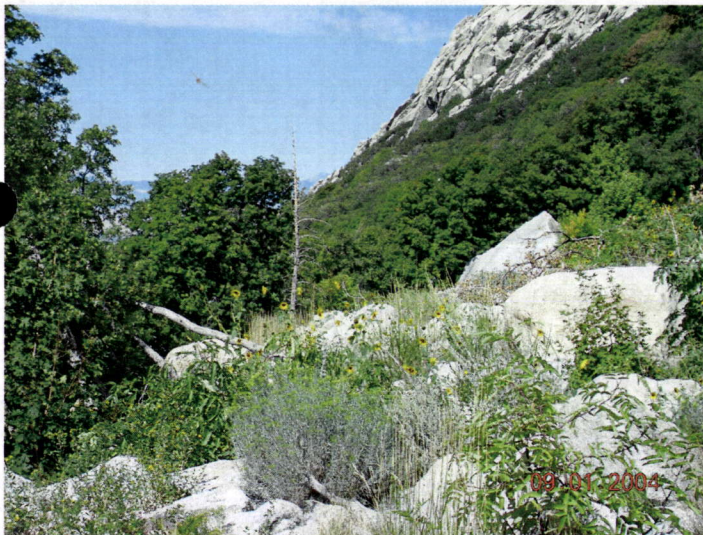
Photo 6. Another part of the reclaimed area. Trees may eventually invade the reclaimed area.
